MUUTOSMÄÄRÄYS **AIRWORTHINESS** **DIRECTIVE**

M 1367/86

1367. Beech. Siipirakenteiden tarkastus

Airworthiness Directives; BEECH 18 Series Airplanes

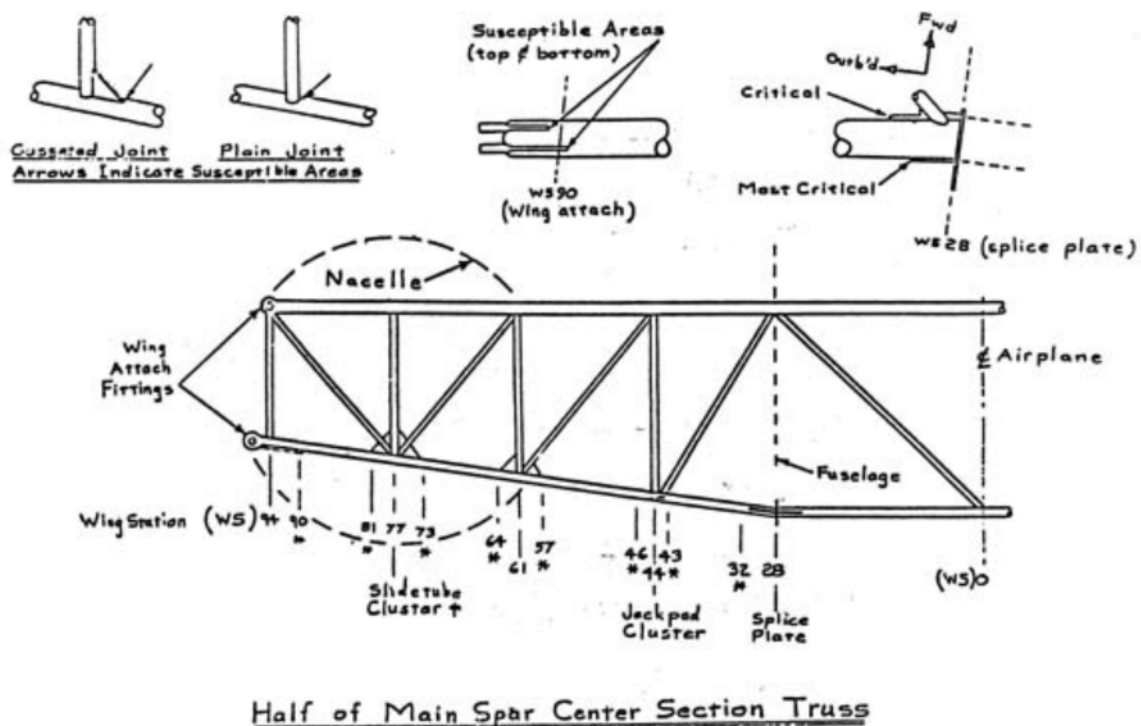
FIGURE 1 AD 75-27-09

* INDICATES AREAS TO BE INSPECTED PER THIS A.D.

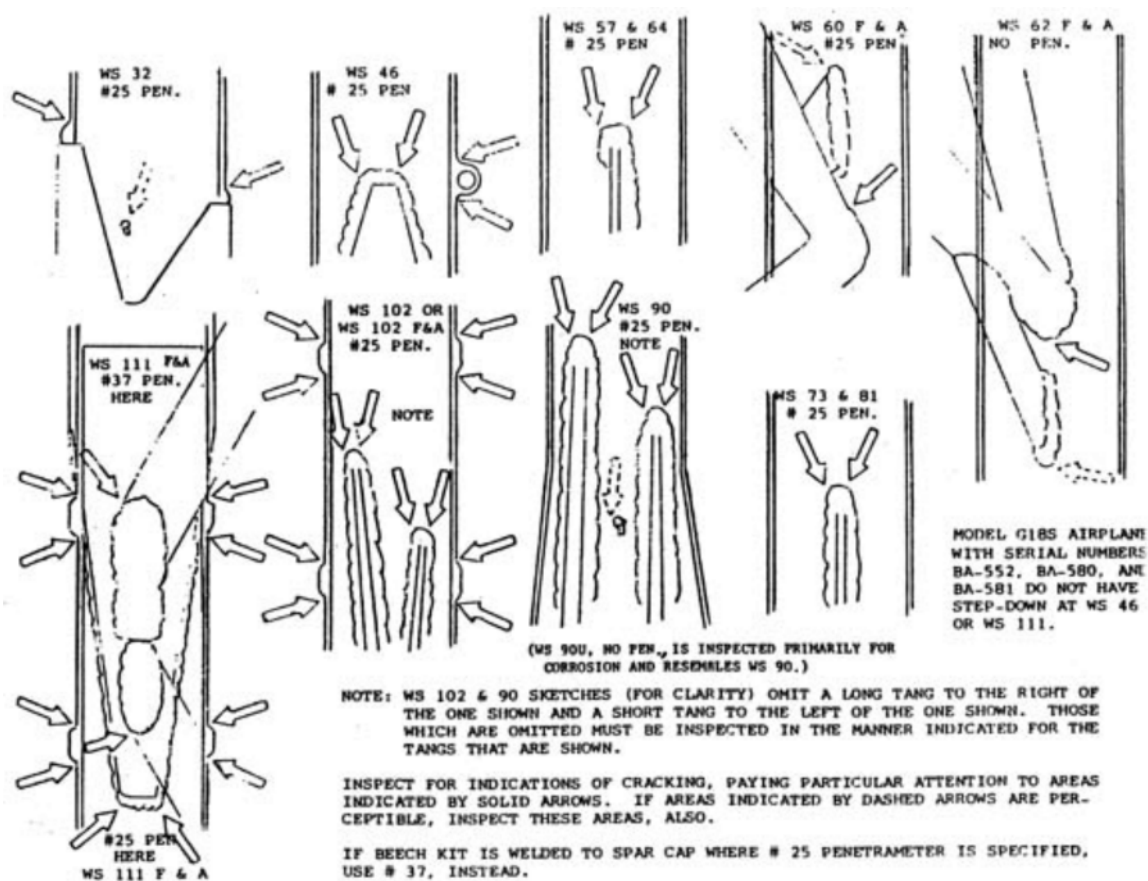
FIGURE 4 AD 75-27-09

90	Tips of welds at clevis tangs, upper and lower surface	Visual, X-ray and either magnetic particle or penetrant
90U	Tips of welds at clevis tangs, upper and lower surface	X-ray
102 & 111	Tips of welds as shown in Figure 4	X-ray

e) Ascertain that neither the airplane nor the source will be moved by wind or other influences, and expose the film so as to obtain 1.5 to 2.8 radiographic density near inspection sites specified in Figure 4 of this directive. Use the same kinds of film and exposure time for WS 62 sites as for WS 60 sites.
