**M 2561/98****Muutos 1****4.8.1998**

Partenavia. Siipien ja vakaimen tarkastus

Airworthiness Directive No. 98-226, dated 02 July, 1998

Wing and stabilator structures - Limit of fatigue life.

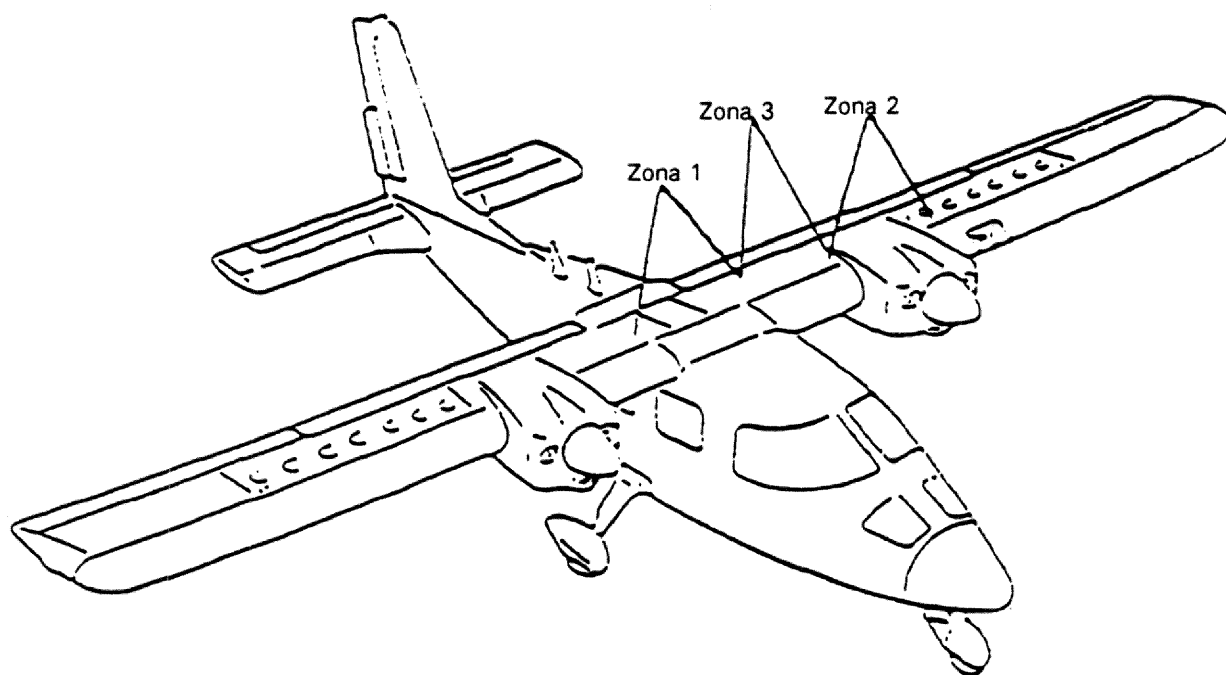
Fig.1

Non Destructive Testing (NDT) procedures are required for wing zones 1, 2, and 3 (see figure 1).

Zone 1 - Spar between wing to fuselage attachments.

Zone 2 - Spar in front of nacelle firewall and adjacent areas.

Zone 3 - Spar between wing root and engine mount.

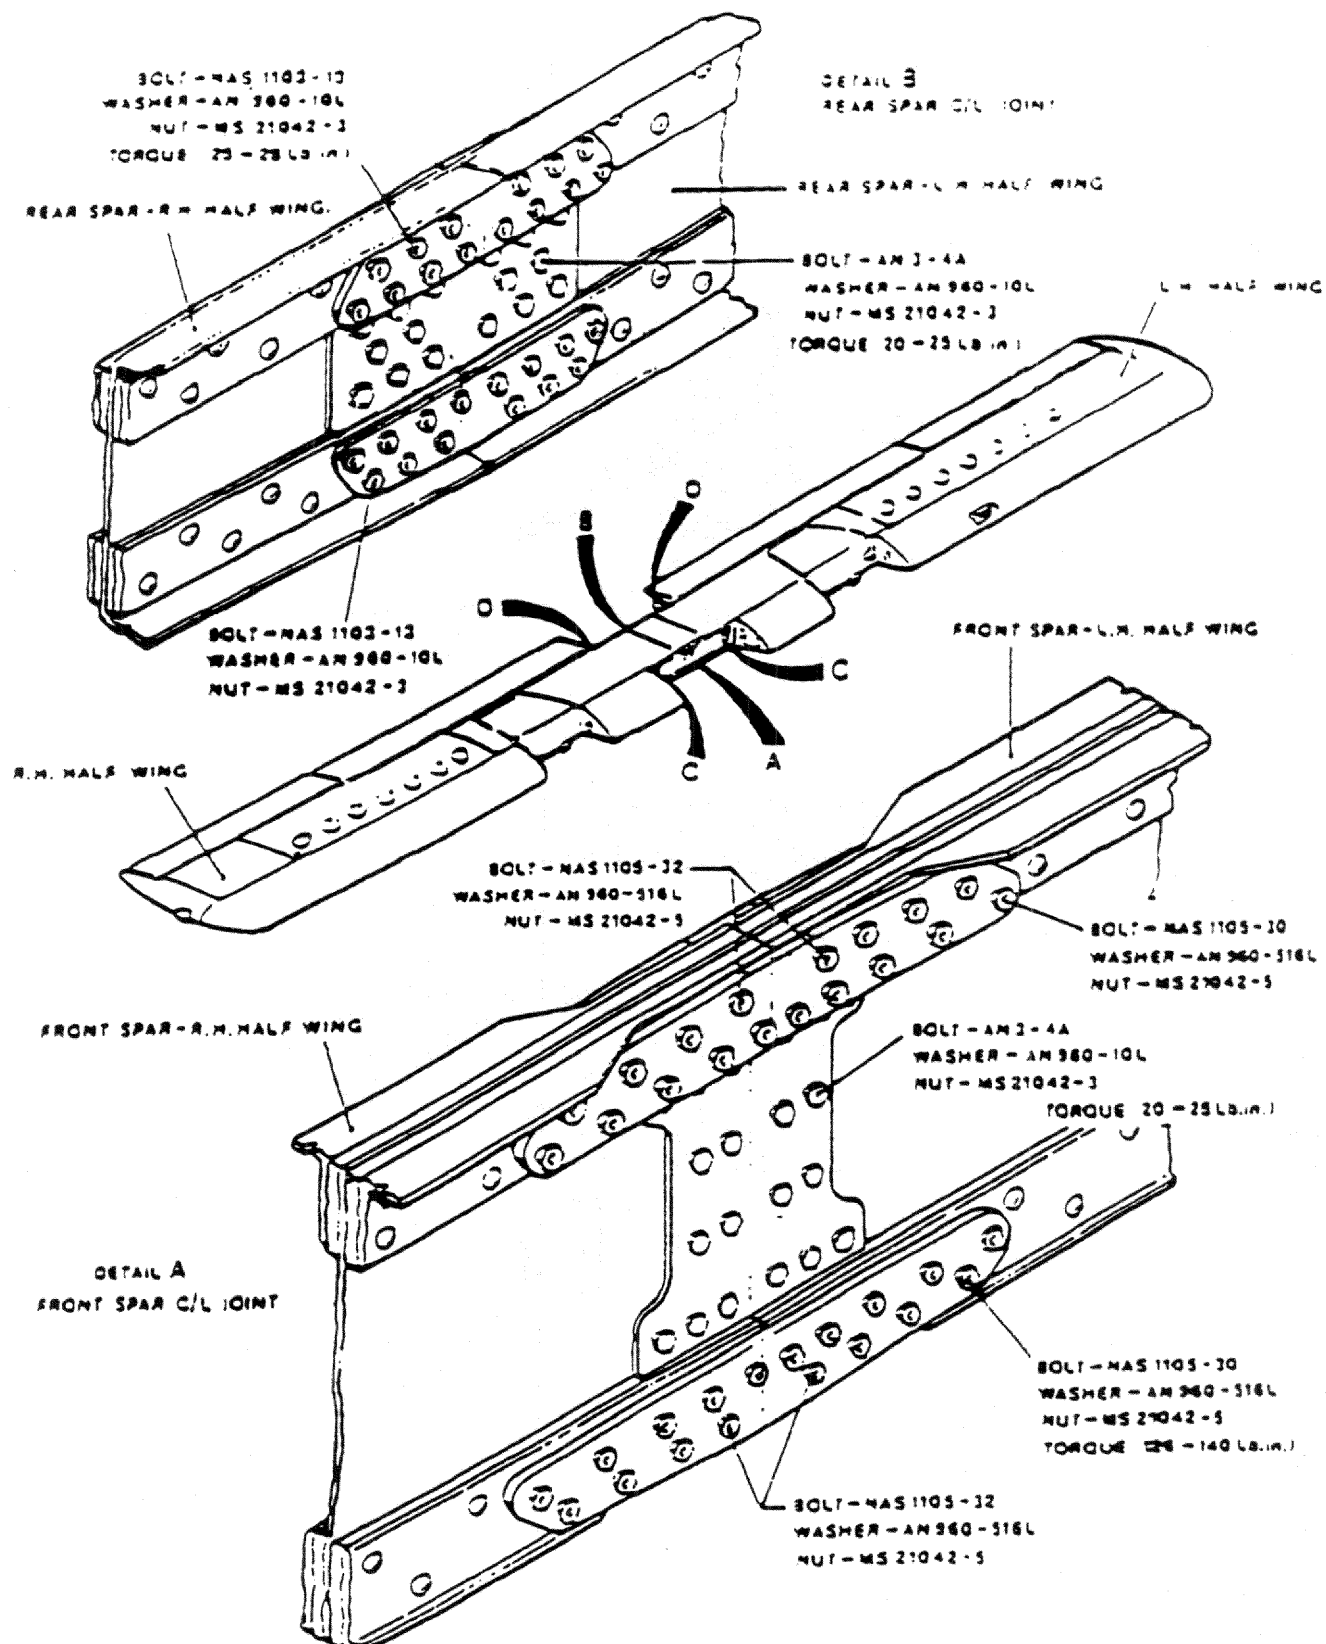
Fig.2

that fasten the upper and lower caps joining plates of the left and right main spars (see figure 2).

- No. 3+3 bolts (sample bolts) that fasten the upper and lower caps joining plates of left and right rear spars.
- No. 4+4 bolts (sample bolts) that fasten the joining plates to the left and right spar web (front and rear spars - see figure 2).

a) Carry out a magnetic particles inspection of the removed bolts.

b) Using a rigid boroscope (appropriate diameter with sight at 90 degrees and view angle of 60 degrees) inspect the holes for corrosion and/or cracks .

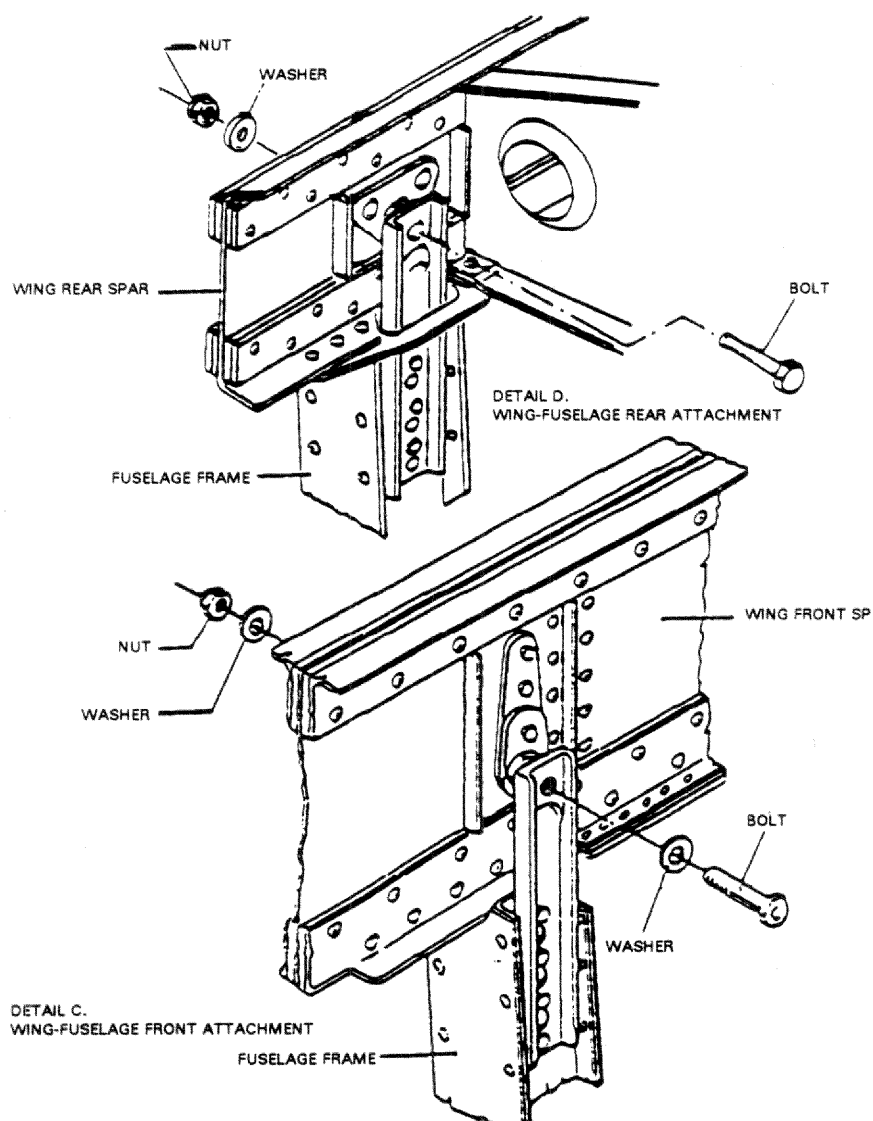
Fig.3

15. Remove the nuts and washers from the four wing-fuselage attachment bolts (see figure 3).

17. Replace or inspect by magnetic particles method the attach bolts.

a) Inspect the wing to fuselage steel attach plates using fluorescent penetrant Type I, Method C, solvent removable.

b) Using a rigid boroscope internally inspect the holes of the wing to fuselage attachment.

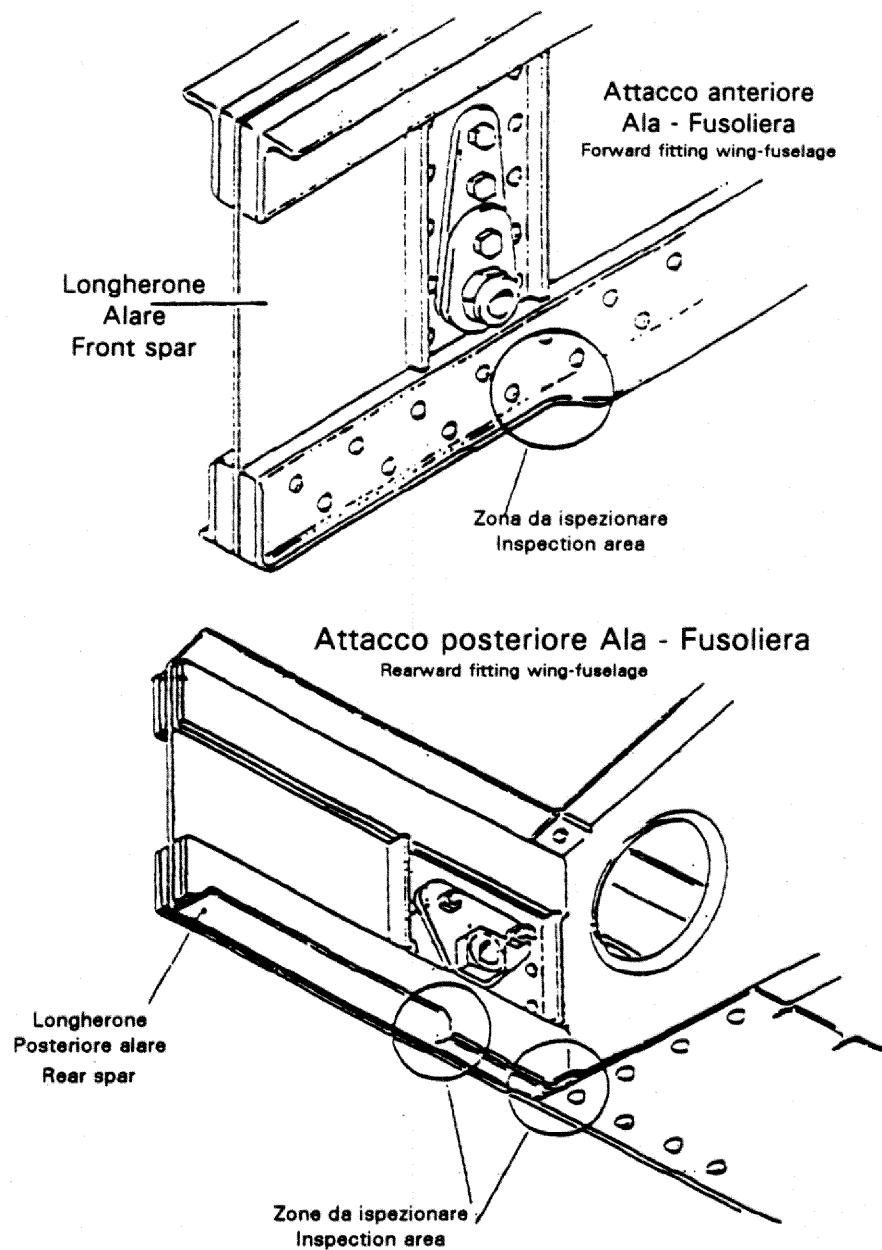
Fig.4

18. Inspect for presence and dimension of typical crack on the structural element of wing in accordance with the accomplishment instructions of S.B. 65 rev. 3, (see fig. 4).

NOTE 1: If a vertical crack with a length greater than 10 mm is found, the repair sketch called for by Partenavia S.B. 65 rev. 3 is no more applicable. In this case if the caps have been repaired according to S.B. 65 rev. 3, remove or

If the length of crack is equal or greater than 10 mm in the vertical part of the cap (forward and/or backward) carry out the repair of damage in accordance with para (D) of this AD.. If no cracks are found or the lenght of crack is less than 10 mm carry out the modification described in the S.B. 65 rev. 3.
