**Aerospool. Laskusiivekkeiden työntötankojen tarkastus**

**Koskee:** Kaikkia niitä Dynamic WT-9-ultrakevyitä lentokoneita, jotka on varustettu tyypin A laskusiiveketyöntötangoilla..

Subject: Swing bearings and flaps push-rods check

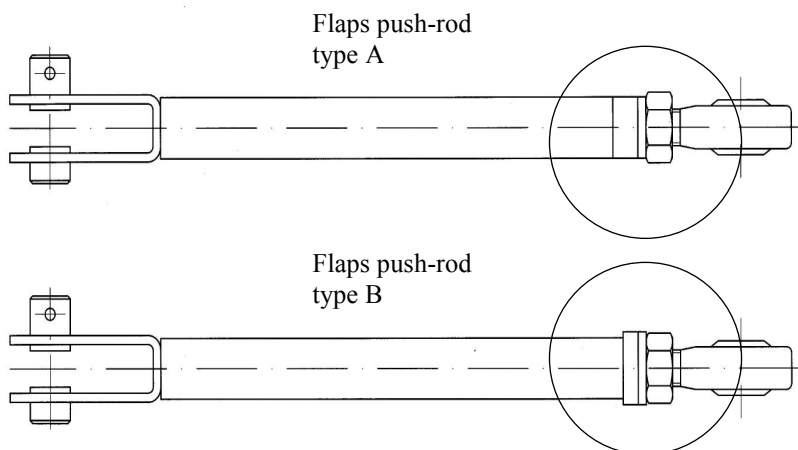
Affected: WT-9 Dynamic, from S/No. DY-002/2001 till S/No. DY-200/2007. Does not apply to aircrafts equipped with flaps push-rod type B (see figure bellow)

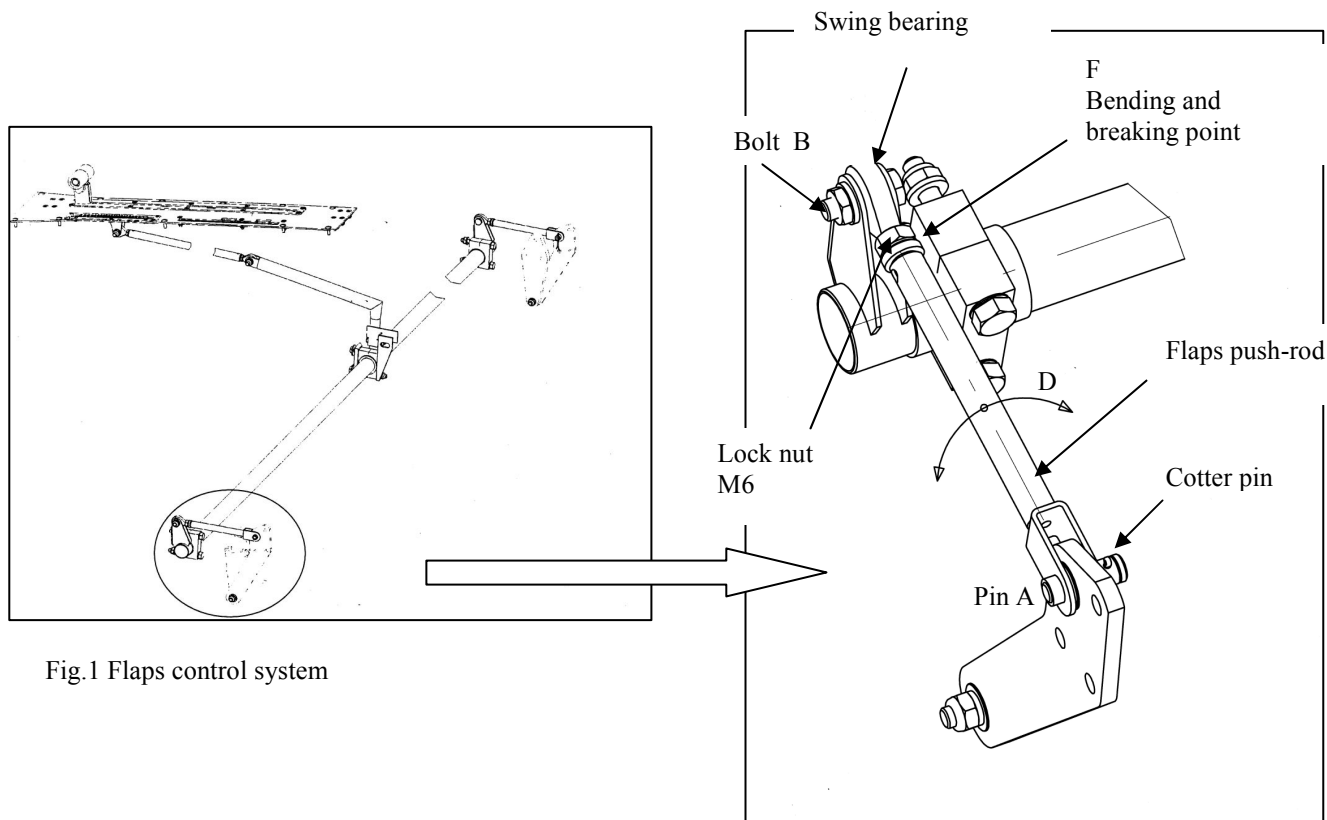
Reason: Occurrence of bending and fatigue break of the swing bearing of flaps push-rod

Arrangements: The aim of the proposed measures is to check alignment of swing bearing with flaps push-rod on left and right flaps and thereby eliminate creation of conditions for the development of fatigue breakage due to bending loads

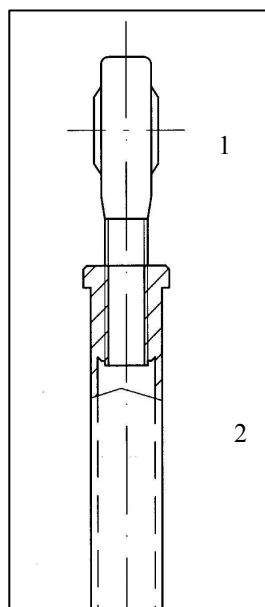
4. Release the lock nut M6 (fig. 2) and unscrew the swing bearing from flaps push-rod
5. Examine swing bearing (1) and flaps push-rod (2) alignment. Verify if the swing bearing is not bended at point F (see bellow)

All right

Wrong

6. If the flaps push-rod is in alignment with swing bearing and bending of the swing bearing is not observed, screw swing bearing back to flaps push-rod
7. Set initial distance "d1", measured at I.3
8. Tighten the lock nut M6
9. Mount the flaps push-rod to aircraft in the inverse order as described in I.2
10. Lock pin A by cotter pin
11. Ensure that after flaps push-rod installation there is a free movement of push-rod when flaps retracted and fully extended (fig.2 position D)

1. If the misalignment of flaps push-rod with swing bearing or swing bearing bending was detected in I.5 then both parts, flaps push-rod and swing bearing, have to be changed for new ones  
If any doubt related to the condition of flaps push-rod or swing bearing make the exchange for new ones or contact the manufacturer
2. Make installation of new original parts following the procedure described in I.6 - I.11
