**Ikarus Comco. Korkeusperäsimen työntötankojen laakerointi**

### **SB-42-016-2013 Elevator Bearing Block**

Inspection of elevator bearing block and exchange of the Polyamide distances.

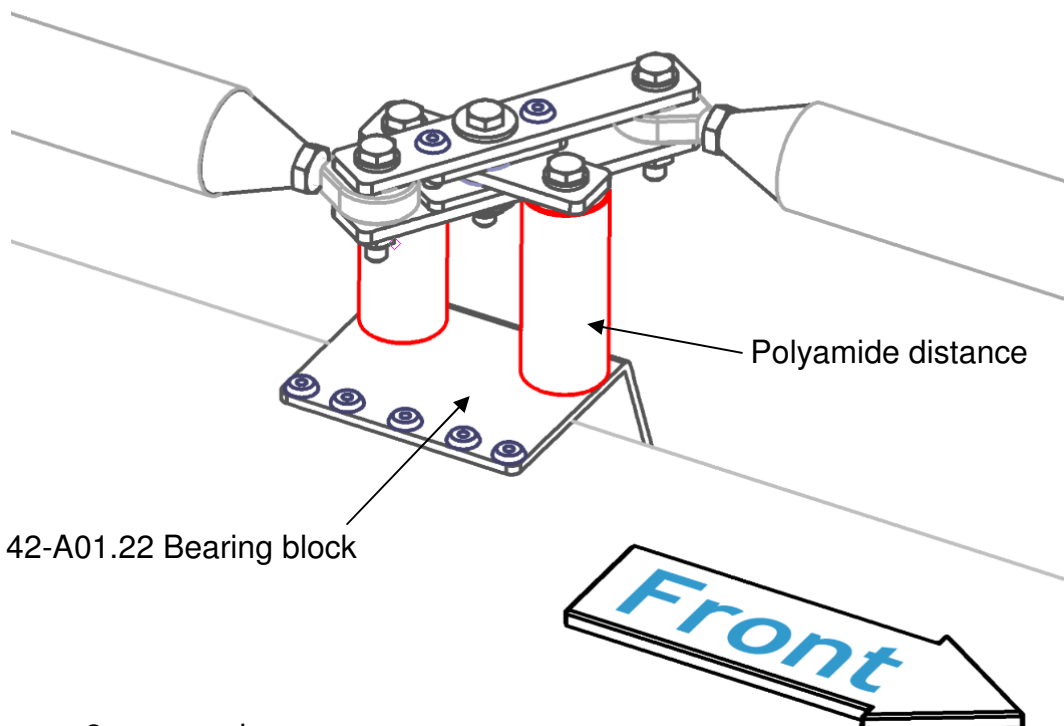
Image 1 previous version

By overloading on the ground (support on stick or elevator) or by clearance in the elevator linkage, the Polyamide distances can cause cracks in the bearing block.

Inspection of elevator linkage on stiffness and straightness of the Polyamide distances. Visual inspection of the elevator bearing block for cracks in the area of the bend. When in doubt, remove the screws securing the Polyamide distances for free accessibility of the bearing block.

Recommended: replacement of Polyamide distances by 42-A15.15A "stop distance elevator balance "(page 3: images 1 and 2)
