**Flylight Airports Ltd. Valmistusaineen tarkastus**

**Koskee:** Kaikkia ultrakevyitä lentokoneita SkyRanger, Skyranger Swift ja Skyranger Nynja.

**Reference:** BMAA Service Bulletin 2462 Issue 2  
**Title:** Inspection for material type – Control Cable Shackles and Elevator Joiner.  
**Applicability:** All UK Sky Ranger, Sky Ranger Swift and Sky Ranger Nynja  
**Author:** Paul Dewhurst, Flylight; Adrian Jones & Ben Syson, BMAA  
**Effective date:** 1 December 2013  
**Classification:** Mandatory

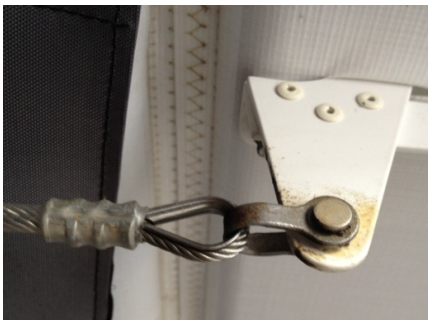
**Control Cable Shackle 604**

A batch of non-optimum stainless steel alloy entered the production process for a limited time. This can result in a reduction of strength and cracking of the affected parts.

The affected parts were manufactured between 2009 and 2012: Sky Ranger Classic and Swift manufacturer serial numbers (not BMAA HB number) 938 to 1053; Sky Ranger Nynja manufacturer serial numbers 09 to 102. Replacement parts supplied from 2009 onwards are also affected.

If any Control Cable Shackles are found to be of the incorrect material they must not be flown with and must be changed before the next flight.

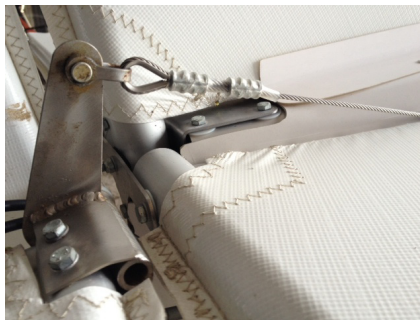
**Elevator Joiner 124**

The parts affected are shown below. Both elevator joiner variants could be affected.

If the Elevator Joiner is found to be cracked it must not be flown with and must be changed before the next flight.

If the Elevator Joiner is found to be of the wrong material (but not cracked) it must be inspected for cracks before every flight and replaced not later than 31 January 2014.

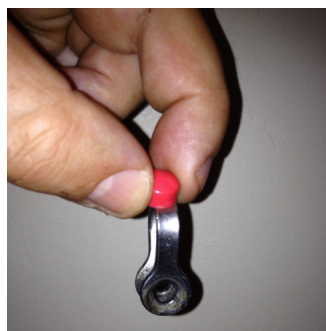
- If the shackle shows no, or weak, attraction to the magnet such that the magnet cannot easily suspend it, the shackle is good.
- If the shackle has strong magnetic attraction such that the magnet can easily suspend it, the shackle is bad and must be replaced before next flight.

**Shackle fails the test by being easily suspended by the magnet**

Use new split pins (ensuring correct size are used) on reassembly. After the Control Cable Shackles have been re-fitted, carefully check for correct reassembly, control sense, deflection angles and free control movement before flight.

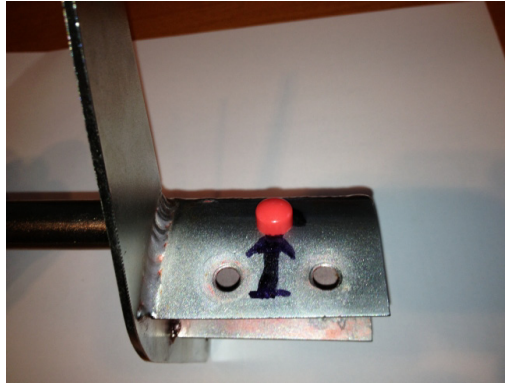
If no cracks are found, next check the joiner with the magnet. The parts to check are the welded on plates with the 6mm diameter attachment bolt holes in them. The check may be done in situ without dismantling from the aircraft. But be aware that the bolts will be magnetic, so check some distance away from them (in the position shown in the photo below).

**Test in the area indicated**

- If the magnet does not stick to the plates, then the Elevator Joiner is good.
- If the magnet sticks to the plate, then the Elevator Joiner is bad and must be replaced no later than 31 January 2014. Also, conduct a visual inspection to ensure no cracks exist before each flight. If cracks are subsequently found the Elevator Joiner must be replaced before flight.

If changing the joiner, use new split pins on the control connections, and new nyloc nuts on the securing bolts. Verify correct reassembly, control sense, deflection angles and free movement before flight.
