BRP Rotax Aircraft Engines. Sulkutulpan tarkastus ja korjaus

Emergency Airworthiness Directive

AD No.: 2017-0101-E

Checking of the correct positioning of sealing plug in ignition housing for ROTAX® Engine Type 912 i (Series)

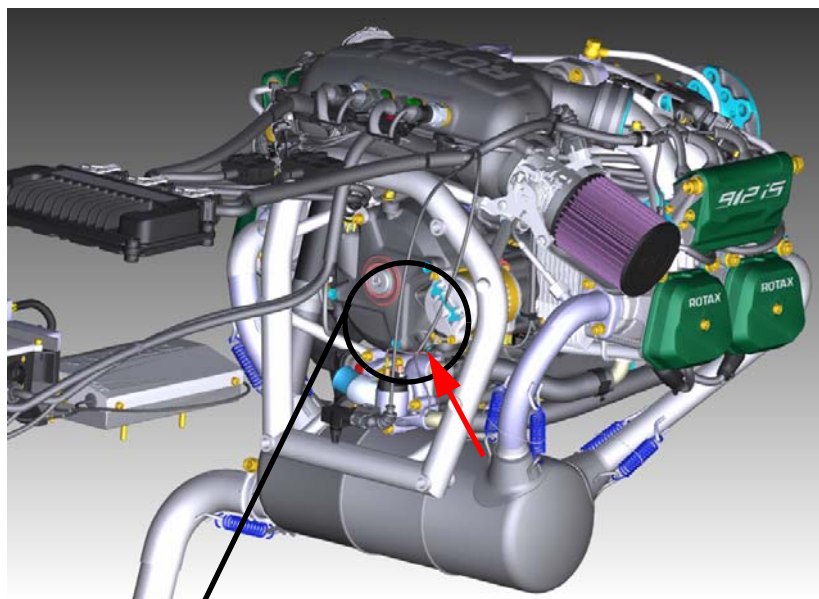
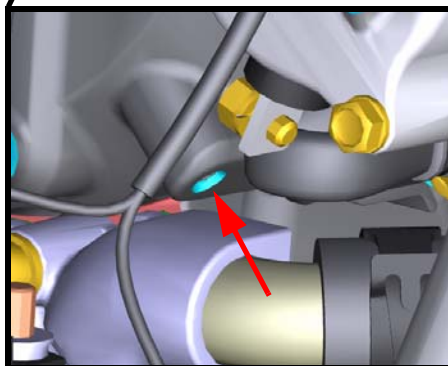
Fig. 1
Sealing plug in ignition housing

Field observation has shown that in isolated cases the sealing plug (see Fig. 1) was not pressed to its correct seating position in the ignition housing. In rare cases this may lead to loss of oil and subsequently loss of lubrication which leads to engine stoppage.

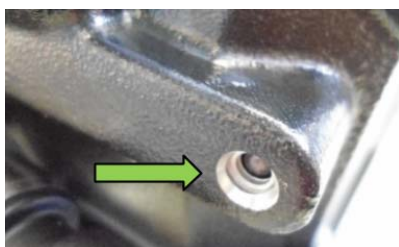
Step	Procedure
1	Check the position of sealing plug in the relevant area of ignition housing assy. See Fig. 2.
2	The sealing plug must show to have been pressed in until the top of the ball is below the edge of the sleeve. See position OK in Fig. 2.
3	If you notice sealing plug position is OK, then there is no need for further procedures. NOTE: If you notice sealing plug position is NOT OK, then see section 3.2.

Sealing plug position "OK"

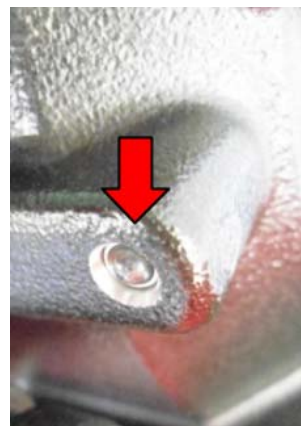
Sealing plug position "NOT OK"

Step	Procedure
1	<p>Correct the sealing plug position with a hammer (max. 300 g / 0.66 lbs) and the relevant insertion jig part no. 676255 as per section 2.6. Intuitively control your manual insertion force just to set the ball in correct position. See Fig. 3.</p> <p>NOTE: The bore must be free of oil, grease and chips.</p> <p>NOTE: Make sure to insert the insertion jig in correct alignment of the center bore / center line of the sealing plug.</p>
