**Suunnitteluvaltion lentokelpoisuusmääräys (Yhdysvallat) AD 2003-24-51****Robinson Helicopter Company. Pulttien tarkastus**

**Koskee:** Kaikkia Robinson R44-helikoptereita.

**Voimaantulo:** 3.12.2003

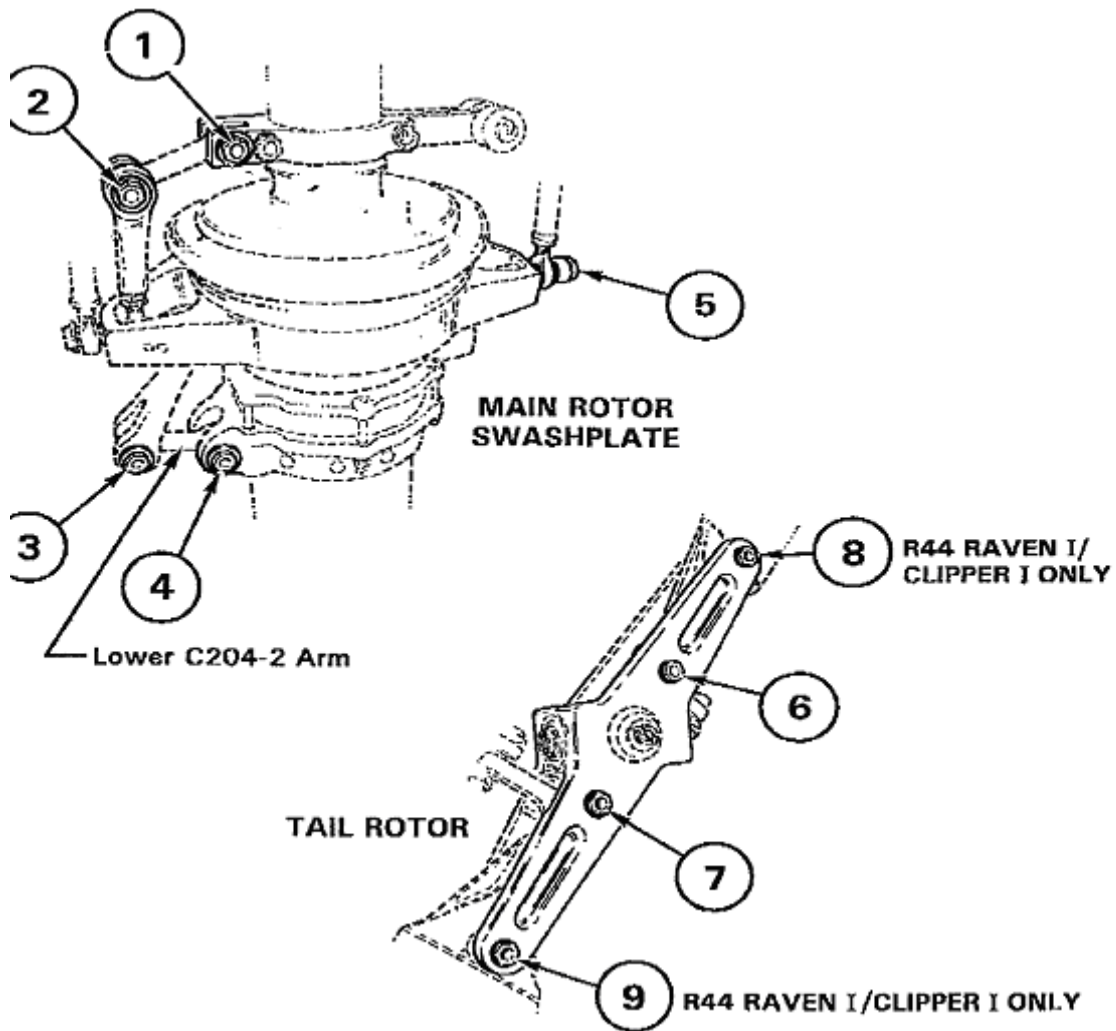
- (1) Determine if maintenance has been performed after February 7, 2003 on the areas specified in Figure 1 of this AD, and determine if any bolt, part number (P/N) NAS6605-31, shown in Figure 1 has been replaced for any reason.
- (2) If any bolt has been replaced, or if it is uncertain whether any bolt has been replaced after February 7, 2003, remove the paint from the bolt head to reveal the vendor identification marking. Determine if the bolt vendor identification is 01DO.

- (1) Visually inspect each bolt for fretting residue under the bolt head, which indicates a loose, potentially cracked bolt.
- (2) Apply 10-15 ft-lb (13-20 Nm) torque to each bolt head and verify no rotation. See Figure 1 of this AD.
- (3) If residue or rotation of the bolt is found, before further flight, replace each unairworthy bolt with an airworthy bolt that does not have a vendor identification marking of 01DO.

Suspect NAS6605-31 bolts

9 places on R44

7 places on R44 II

(e) For the helicopters specified in paragraphs (b) and (c) of this AD, within 10 hours time-in-service or by December 31, 2003, whichever occurs first, replace each bolt, P/N NAS6605-31, that has vendor identification marking 01DO on the bolt head, with an airworthy bolt, P/N NAS6605-31, that has an alternate vendor identification marking.

(f) Bolt, P/N NAS6605-31, with vendor identification marking 01DO on the bolt head, is NOT ELIGIBLE for installation on any helicopter.
