Pelastus- ja varavarjojen laukaisukahvojen pinnit

Koskee: Kaikkia pelastusvarjoja ja varavarjoja.

Manufacturer Product Service Bulletin

Subject: Capewell Supplied Pins and Ripcords

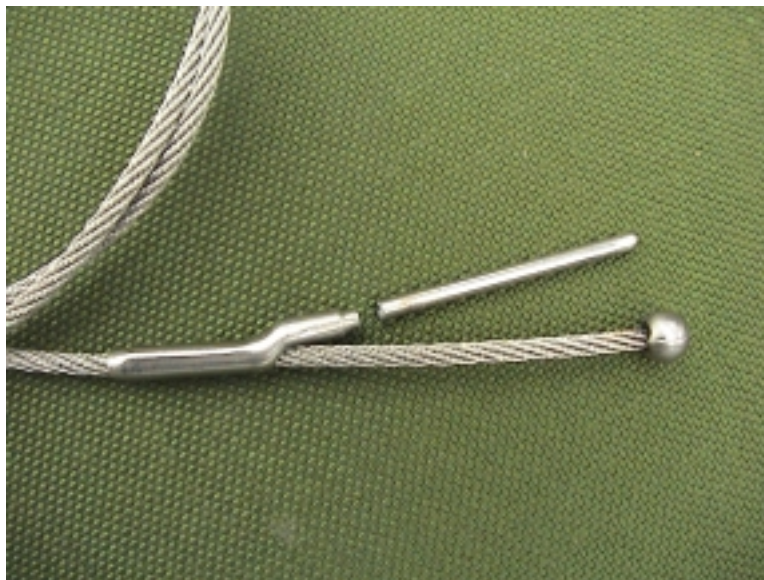
Capewell Components LLC has received (3) reports from (3) customers of (4) ripcord pins that broke. All (4) pins were reported to have broken under very low force. All (4) pins are reported to have broken on the blade section of the pin, approximately 1/8" (3 mm) from the shoulder of the pin. A broken pin is pictured below.

Broken Ripcord Pin

Tarkasta pelastusvarjon ja varavarjon laukaisukahvan pinni ennen varjon seuraavaa käyttöä liitteenä olevan Capewell Service Bulletinin CW03-01 Test 1 tai Test 2 ohjeiden mukaisesti, ellei sitä jo ole tarkastettu aikaisemmin. (Suomen Ilmailuliiton Kalustotiedote II/2003 päivätty 18.7.2003 viittaa samoihin ohjeisiin.) Jos pinni taipuu tai siihen tulee muita muodonmuutoksia tarkastuksessa, vaihda kahva ennen varjon käyttöä uuteen, joka on toimitettu tehtaalta 15.7.2003 jälkeen.

Status: MANDATORY TEST – This is a one-time TEST. One of the two tests (either TEST 1 or TEST 2) must be performed and marked per test procedure.

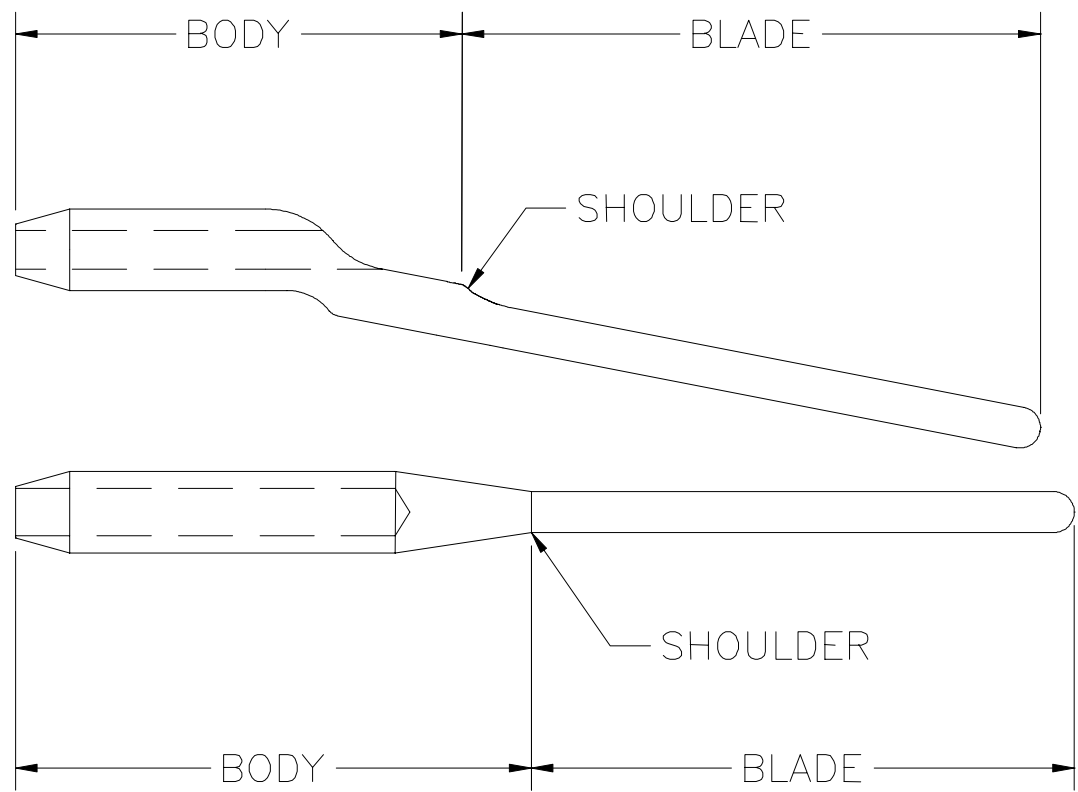
Affected Ripcord Pins are: MS70107 (angled), PS70107 (angled), 61C4304 (angled); 55A6480 (terminal)

The figure below is provided for clarity to all procedural instructions.

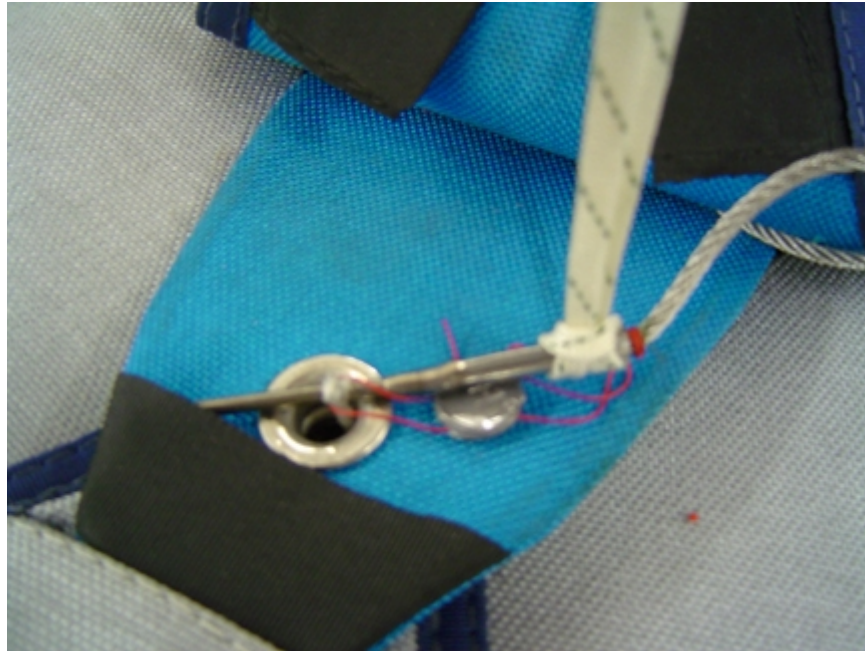
FIGURE 1

3. Take the suspension line and tie the two ends together with an overhand knot forming a loop.
4. Route the loop around the body of the pin to form a lark's head knot as close to the cable entrance end of the pin body as possible (Fig. 1).

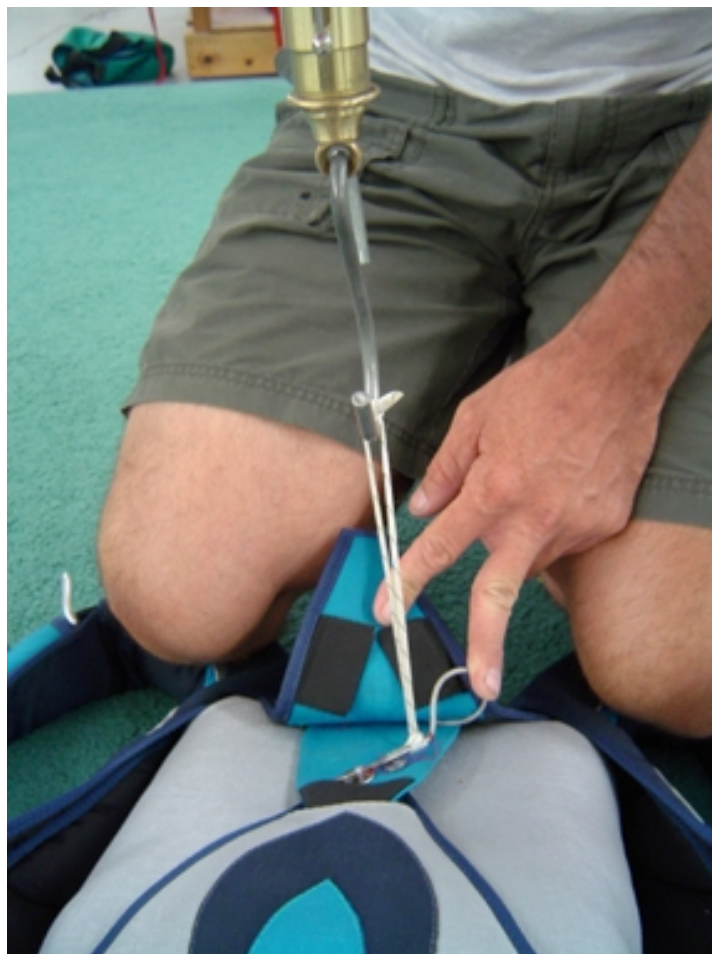
FIGURE 2

5. Secure the other end of the loop to the spring scale.
6. Apply a load of 15 lbs. (6.8kg) straight up and 90 degrees to the axis of the pin for a period of 3 seconds and then release the load (Fig. 2). Inspect the pin for any deformation or bend. If the pin is straight, continue with step 7 below. If the pin is not straight, as visible without magnification, remove the pin/ripcorder from service immediately.

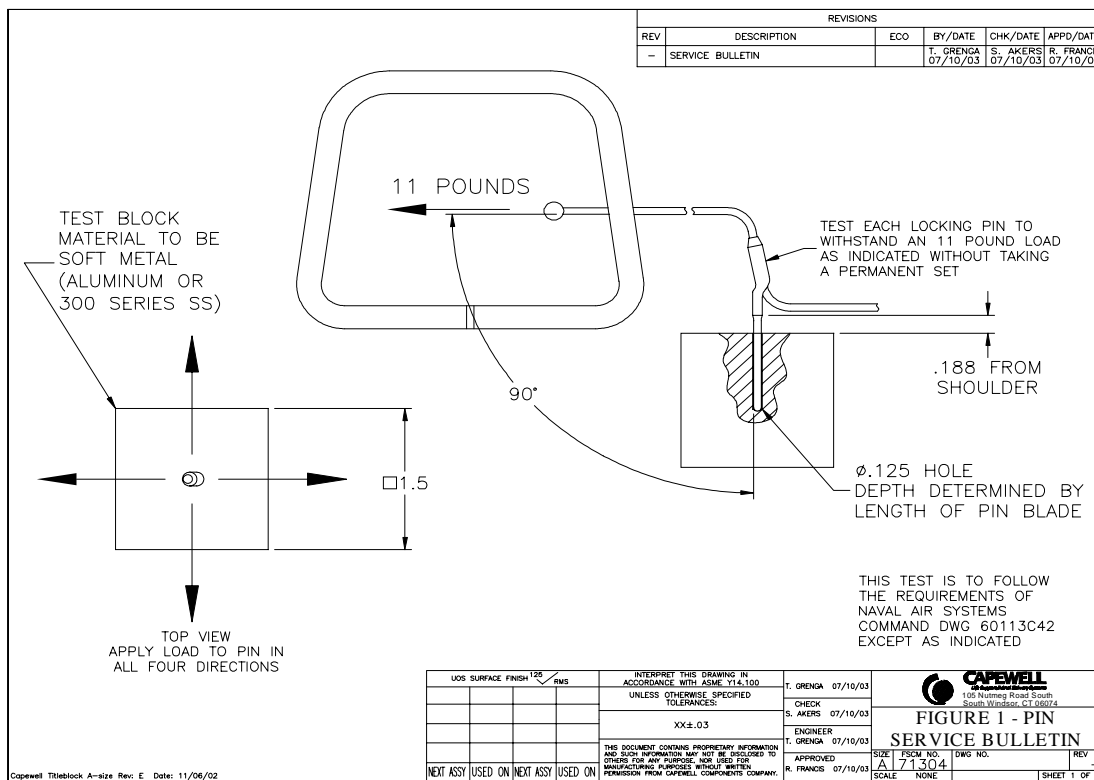
1. Place pin in test block per Figure 3 (below). NOTE: The pin block hole may be VERTICAL or HORIZONTAL
2. Apply 11 lb. force 90 degrees perpendicular to the pin blade.

FIGURE 3
All dimension in inches

3. Remove pin from block and inspect:
 - For straightness: Pins in excess of .005 (.12 mm) deformation along the blade of the pin should be removed from service.

- For surface anomalies using 10x magnification. If any surface anomalies (dents, cracks, chips) exist, the pin should be removed from service.
4. Mark the inspected side of the pin with the felt marker to avoid repeatedly testing the same side of the pin
